The Radiola 281

Warwick Woods.

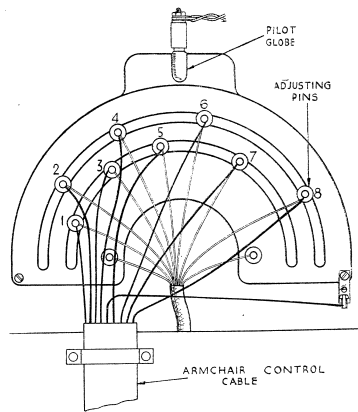
Automatic adjusting pins and Armchair Control connections.

To set the pre-set buttons to the desired stations, it is necessary to (1) set the 'Fidelity' control to position 1, (2) press the 'Manual' button, (3) manually tune to the desired station, (4) hold the 'Manual' key down and press pre-set key No 1; both keys will stay down, (5) move adjusting pin No.1 along the slot until the

pilot globe mounted above the adjusting pins is extinguished. This operation is then repeated for the remaining seven buttons.

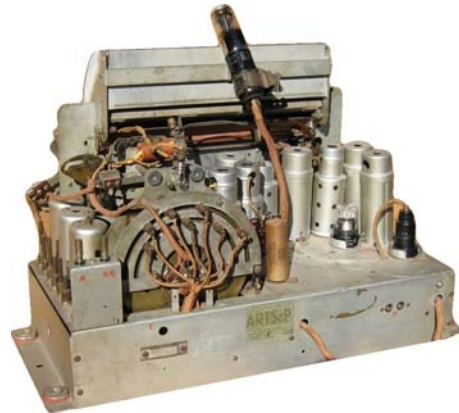
The valve compliment is: 6U7-G RF Amplifier, 6K8-G Mixer, 6J7-G separate Oscillator, 6J7-G Oscillator Control, 6U7-G 1st I.F. Amplifier, 6U7-G 2nd I.F. Amplifier, 6H6-GT Detector, AVC and AFC, 6R7-G 1st Audio, 6J7-G 2nd Audio, 6J7-G Phase Splitter, two 6V6-G Output, 5V4-G Rectifier and 6U5 Tuning Indicator.

The inclusion of AFC is not common in domestic receivers of this vintage. The function of the AFC circuit is quite complex but in simplified terms, it automatically changes the frequency of the heterodyne oscillator so that the correct intermediate frequency is provided for the I.F. Amplifier. The circuit consists of an I.F. Discriminator, part of the 6H6-GT, that provides a control voltage of the correct polarity to the Oscillator Control valve which in turn adjusts the frequency of the 6J7-G Oscillator valve. This corrects any drift in the oscillator and ‘locks in’ the selected station.
